**RESEARCH AND DEVELOPMENT TESTING
OF YTTRIA/RARE EARTH
STABILIZED ZIRCONIA MATRIX BRICKS
IN THE PILOT TEST UNIT (PTU) AT AEDC**

C. R. Tinsley

ARO, Inc.

November 1972

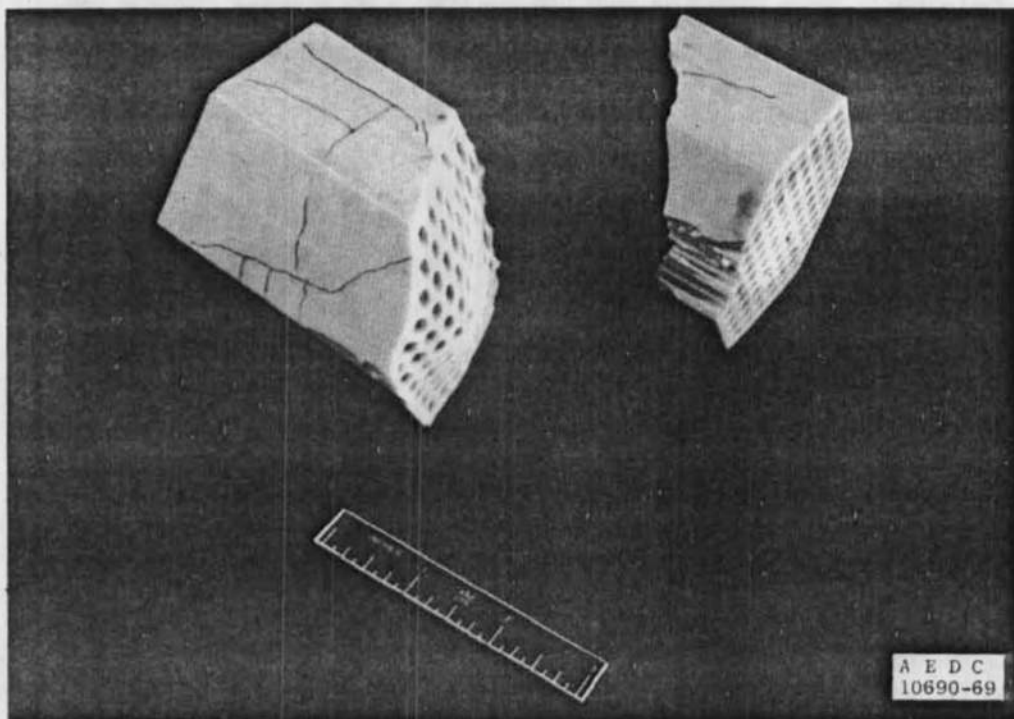
b. Brick Placed into Matrix Pre-Heat Soak, Column 1, 9.25 w/o, Coors

Inspection of the matrix revealed that excessive fracturing and cracking had occurred as a result of the reactant flow anomaly. Of particular note was the tendency of relatively long bricks to fracture into shorter segments. All matrix bricks inspected including the original cored bricks were hard indicating no destabilization. Pertinent photographs taken during the inspection are presented in Fig. 10.

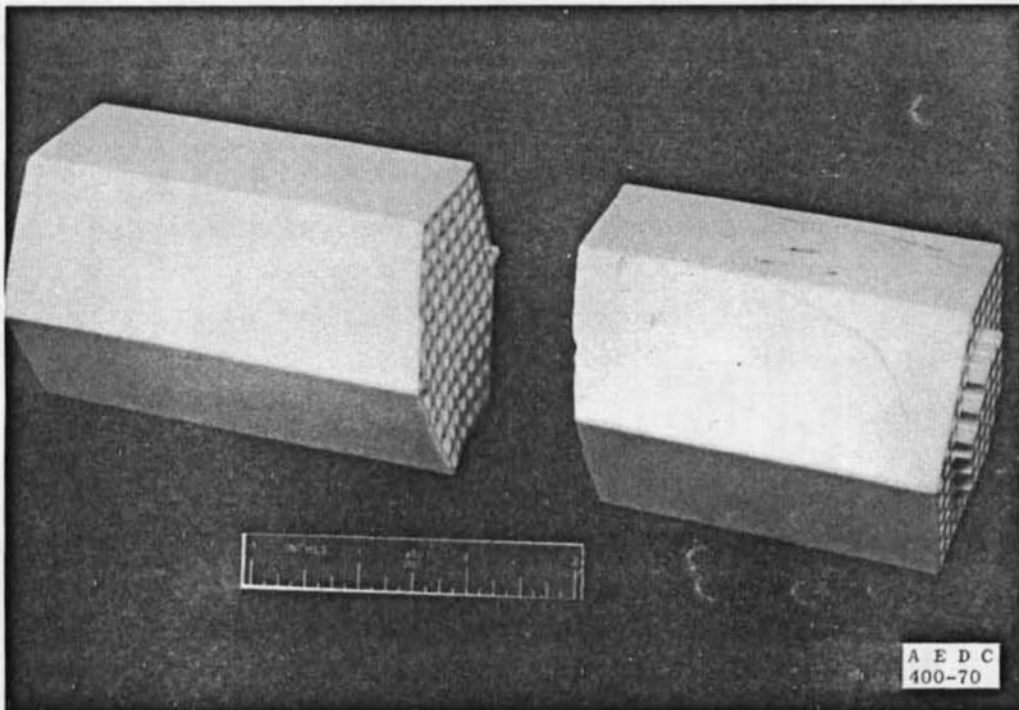
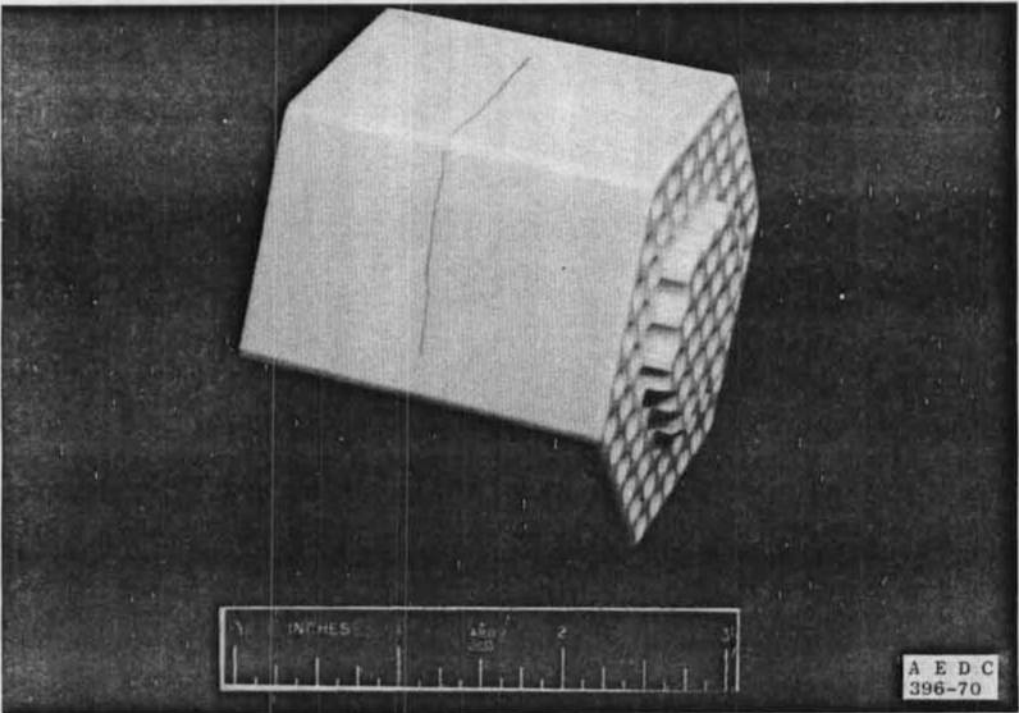
Fig. 12 Matrix Sample Bricks, Post-Run 37

Inspections after run 37 revealed (1) that the sample matrix bricks installed before run 33 were in good condition with some hairline cracking and (2) that heater combustion chamber insulation refractories exhibited further degradation. Pertinent photographs taken during the inspection are presented in Figs. 12 and 13.

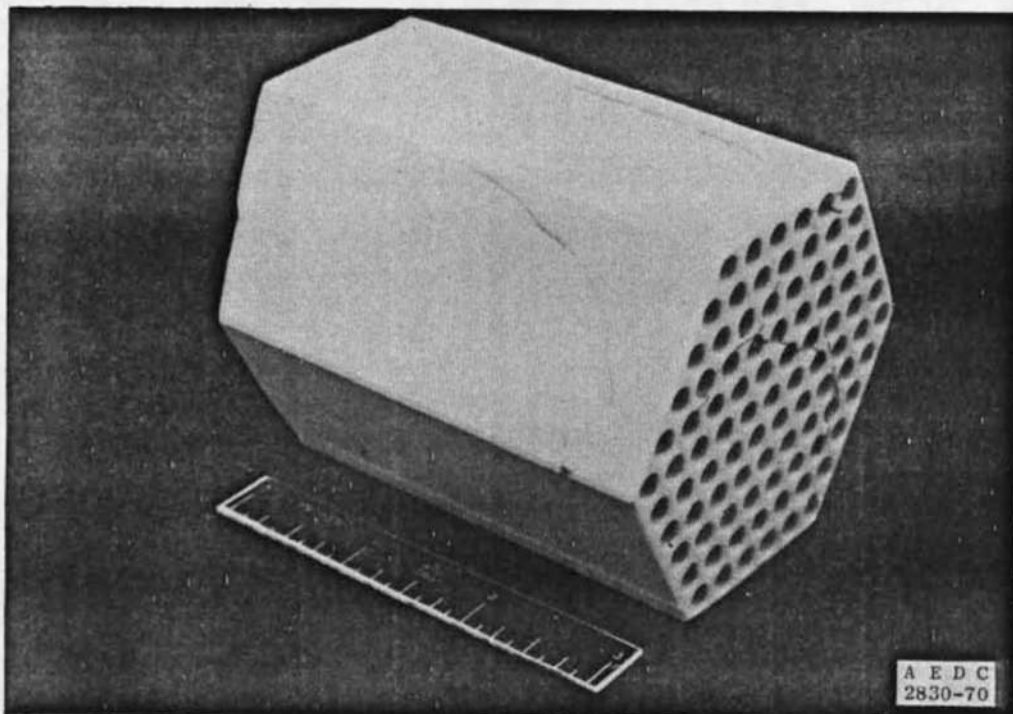
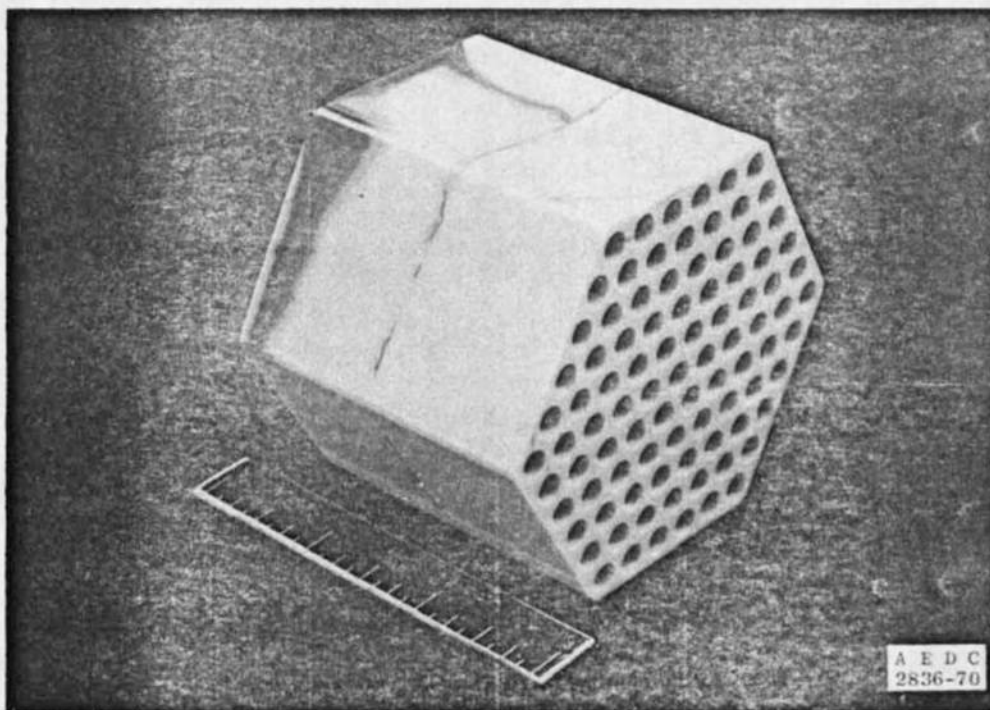
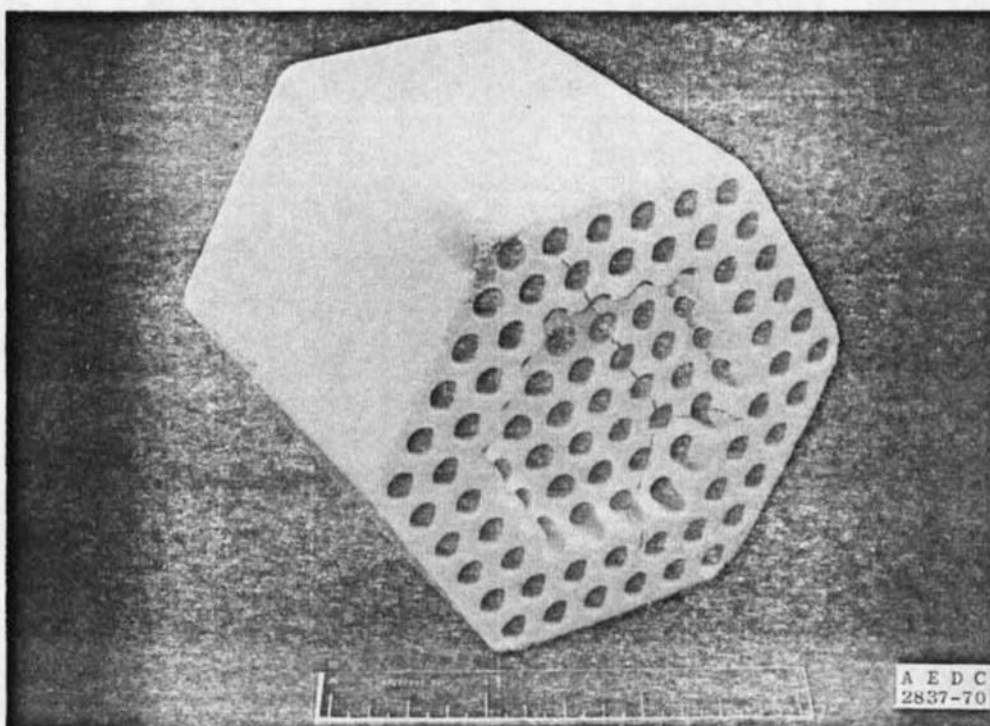
Fig. 15 Matrix Sample Bricks, Posttest 38

Posttest 38 inspections revealed (1) that nitric acid erosion was the prime factor causing burner deterioration and (2) that selected matrix bricks inspected were in good condition with only a few additional hairline cracks. Pertinent photographs taken during the inspections are presented in Fig. 15. The bricks depicted in Figs. 15a and b were also photographed after run. 37 (see Fig. 12) so that the effects of testing could be documented in typical matrix bricks.

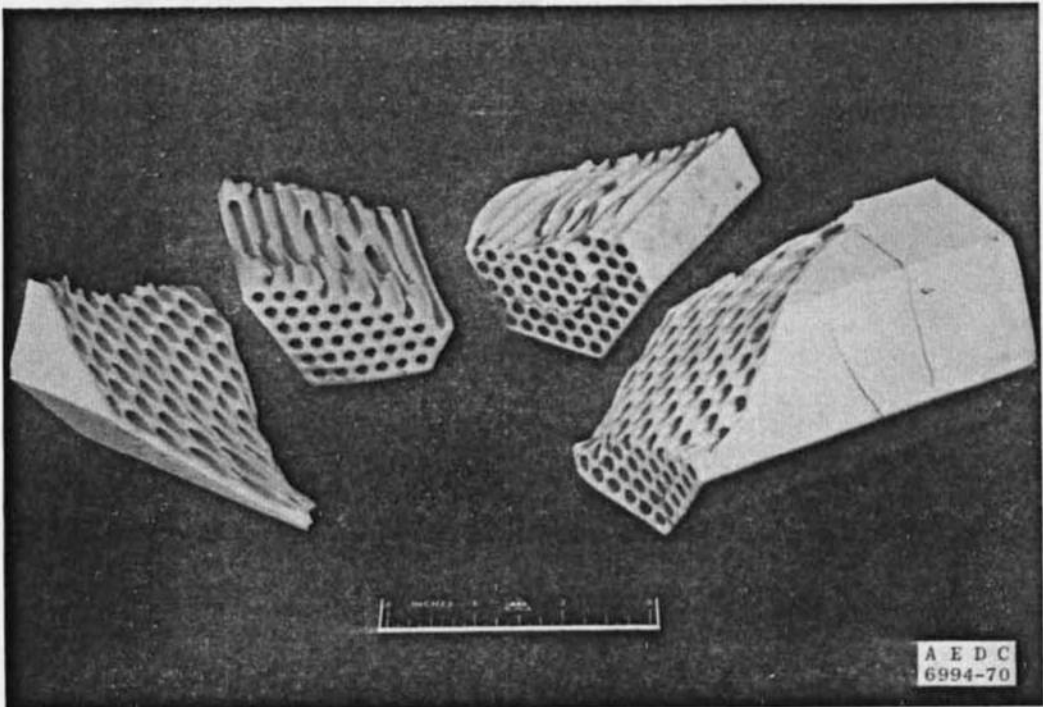
b. Column 8, 12.6 w/o, Coors
Fig. 17 Post-Run 44 Matrix Inspection

After runs 40 through 44, the top foot of the cored matrix was removed for the first major inspection. Laboratory analysis of selected bricks did not indicate destabilization. Pertinent photographs taken during the inspection are presented in Fig. 17. By referring to Fig. 14, all bricks shown in Fig. 17 can be identified as to location and number of runs that they remained in the matrix.

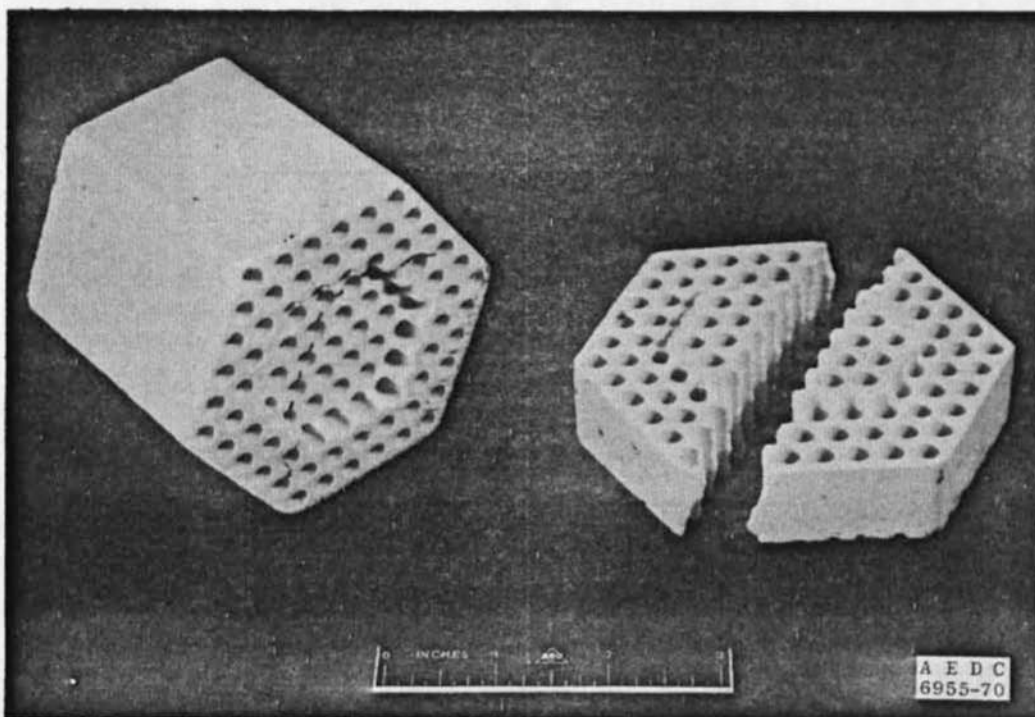
g. Column 13, 9.25 w/o, Coors

Following the removal of the zirconia matrix and the top course of alumina matrix bricks, a type of crack-or-fracture-pattern was noted which was unlike those found in the sample bricks. With this type of cracking, an oval-shaped portion of a brick side appears to have partially collapsed toward the inside of the brick. However, some bricks appear just the opposite; that is, the outer brick surface appears to have expanded radially outward leaving the oval midsection. This crack pattern may be noted in both the alumina bricks and the original 9.25 w/o heater bricks as is depicted in Figs. 26c and 27c. This phenomenon is also present in Fig. 17g which shows an original heater brick removed from the matrix after run 44.

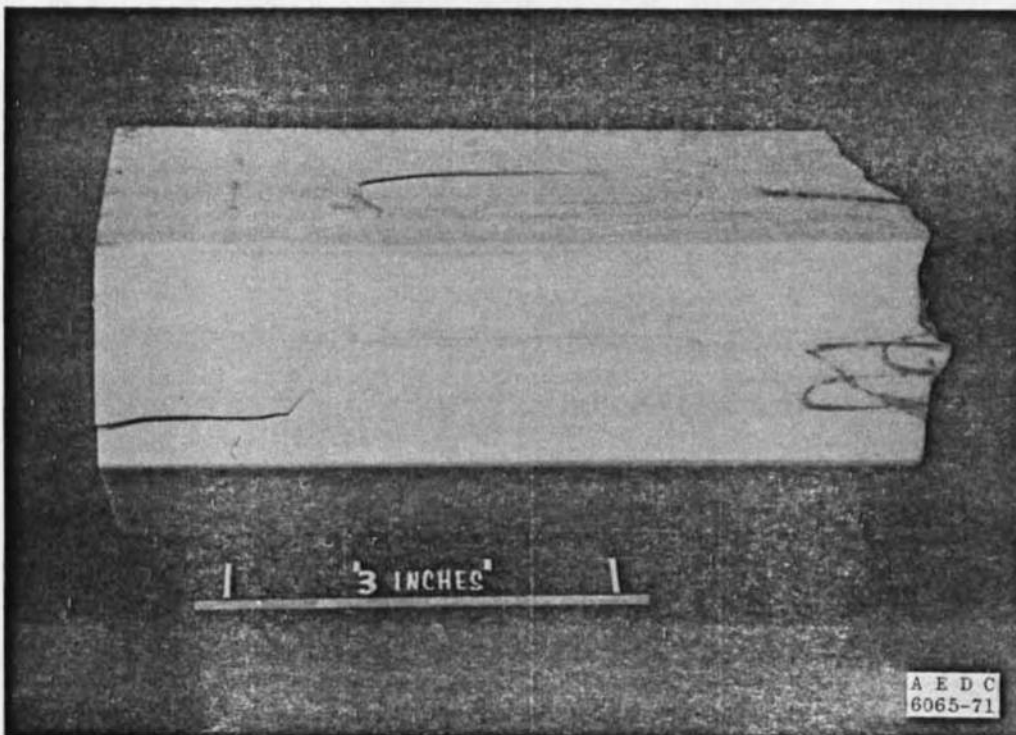
b. Center Portion of the Alumina Matrix at the Interface

The top course of alumina bricks at the zirconia/alumina interface was removed from the matrix. Brick length was approximately 11 in. A photograph of the alumina matrix at the interface is presented in Fig. 27a. Three of the alumina bricks had been removed from the matrix before the photograph was taken. During removal of the top course, seven bricks located centrally in the matrix were fused together and were removed as a unit. A photograph of these bricks is presented in Fig. 27b. It is evident in Figs. 27a and b that, at the interface, the centrally located bricks had become plastic and distorted as a result of high temperature. This distortion was only present at the top surface of the bricks. Presented in Figs. 27c through e are additional photographs of alumina bricks from the top course. These photographs are presented so that crack and fracture patterns in the alumina bricks may be observed.

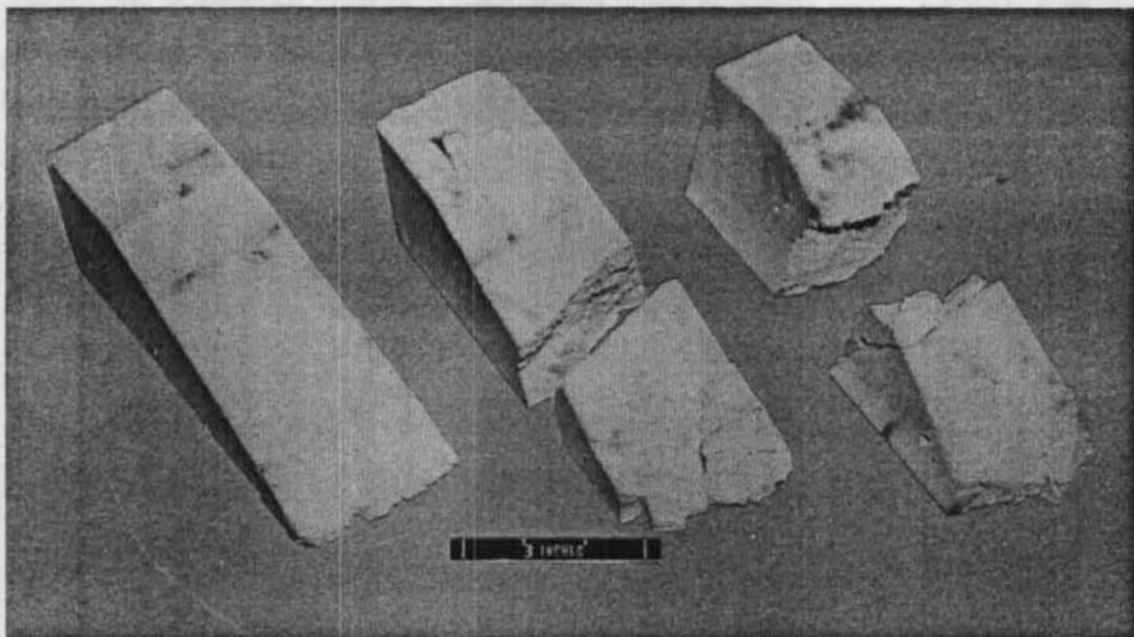
b. Heater Dome Support Shelf and Top of Matrix Refractories
Fig. 28 Various Heater Refractories, Post-Run 85

Presented in Fig. 28 are photographs of various heater insulation refractories taken during the removal process. The condition of typical dome hot face refractories is illustrated in Fig. 28a. The steel shelf may be noted in Fig. 28b along with the bed liner bricks and the first layer of insulation. The outer layer of insulation cannot be seen in this photograph because of the heater shelf. Presented in Figs. 28c through h are photographs of various heater insulation and liner bricks. Crack and fracture patterns shown in these bricks are typical for the various types of insulation refractories.

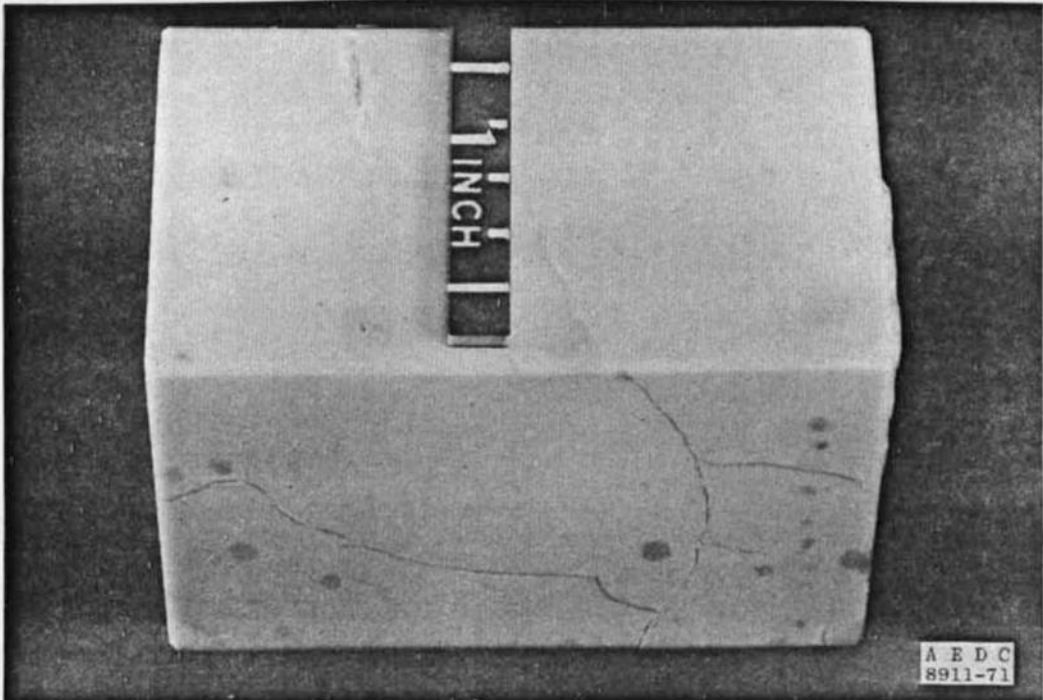
a. Side "A"

Occasionally stress marks will be discovered on the matrix bricks which are typical of those shown in Fig. 29. These horizontal indentations are caused by bricks becoming slightly misaligned as the matrix shifts with changing temperature. In cases of pronounced indentations such as these, the air passages in the brick adjacent to the surface and at the point of indentation remain slightly distorted, indicating that, because of elevated temperature, the brick was relatively soft at the time the indentation was made.

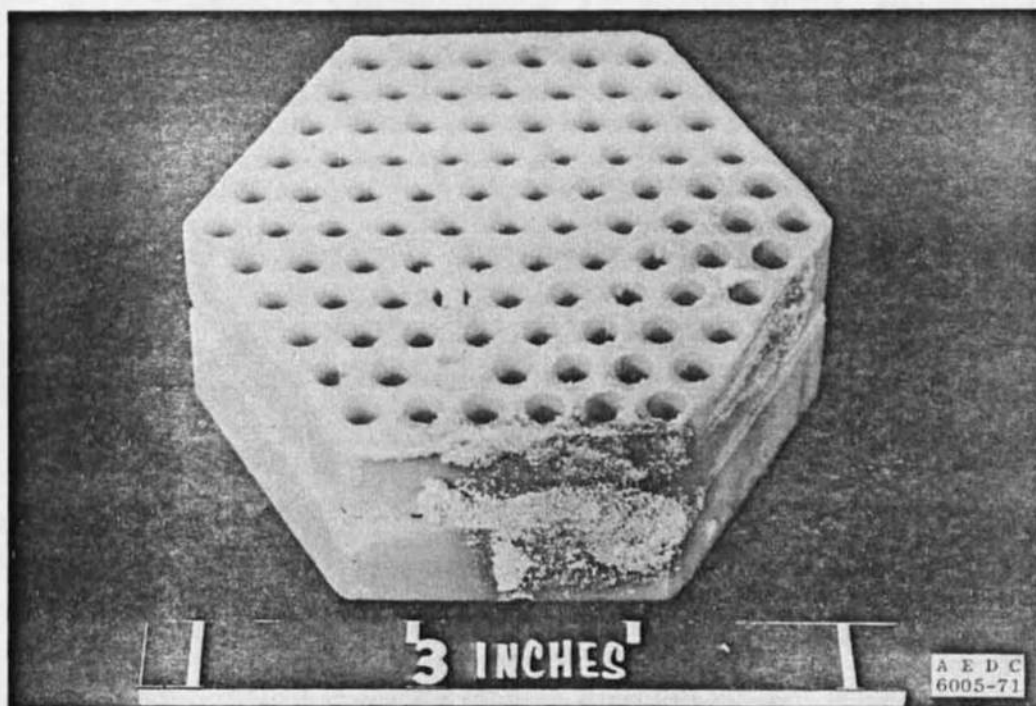
b. Zircoa, 10.8 w/o, Location 13-6

Presented in Fig. 31 are matrix bricks, photographed during the post run 85 inspection, upon which material has been deposited and/or removed. The composition of material in these areas was analyzed and found to vary only slightly from the remainder of the bricks. Bricks which possessed this appearance were as follows: brick numbers 10-1, 10-2, 10-3, 12-2, 12-3, 13-5, 13-6, and 16-5. All of these bricks were situated in matrix columns adjacent to the bed liner. Brick 10-1 (Fig. 31a) appears to have experienced localized melting, resulting in the removal of material from the brick. To a lesser extent, this may also be observed of brick 13-6 (Fig. 31b). Presented in Fig. 31c are bricks 10-2 and 10-3 which are fused together. Again a localized area of the brick appears to have melted. In addition, deposits of yttria/zirconia material are fused to the bricks.

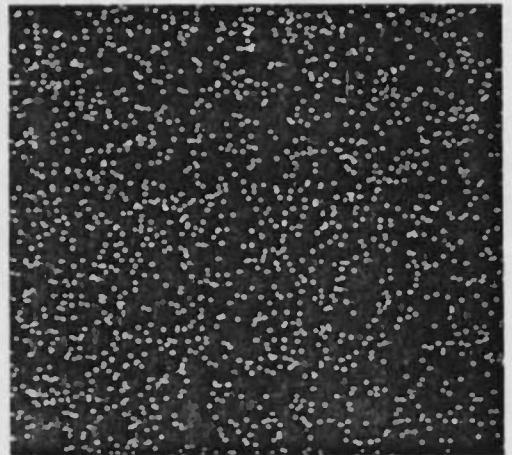
c. $\text{Y}_{\text{L}\alpha}$ (500x)

Fig. VII-2 Electron Microprobe X-Ray Photographs of 9.25 w/o $\text{YRE}_2\text{O}_3\text{-ZrO}_2$
Sample from 12-ft Level

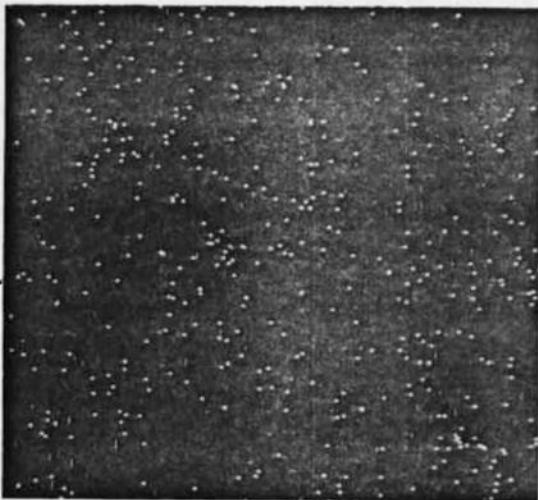
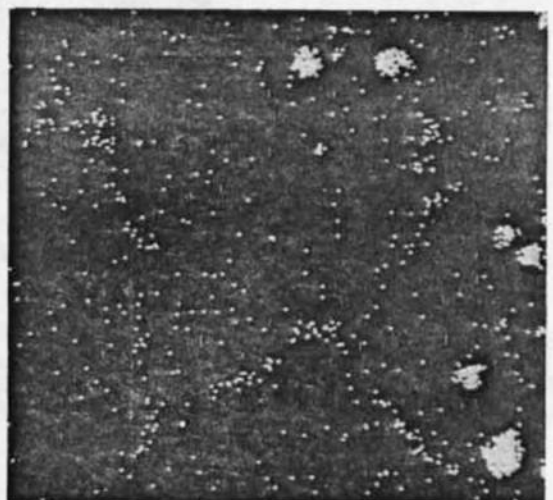
f. Ca_{Lα} (500x)

g. Al_{Lα} (500x)

Fig. VII-2 Concluded
